Total Home Inspections Pty Ltd

# Pre-Purchase Inspection - Residential Building Report

Complies with Australian Standard AS 4349.1- 2007 Inspection of Buildings Part 1: Pre-Purchase inspections - Residential buildings

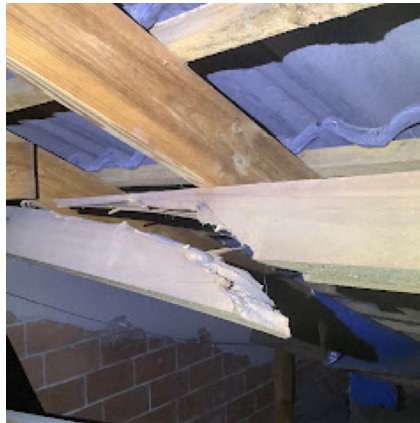
Defect 1. - Roof Void

Defect Location:	North Side
Defect Summary:	Roof Framing
Type of Defect:	Damage, Structural
Description:	Underpurlin has snapped
Ongoing Consequence:	Sagging to roof frame and damage to roof exterior
Opinion of Cracking:	Not Applicable
Building Professional:	<b>Note: This defect should be referred to a qualified building professional for the repairs/scope of work required.</b>
	Building Professional Required: Carpenter

Owner to rectify

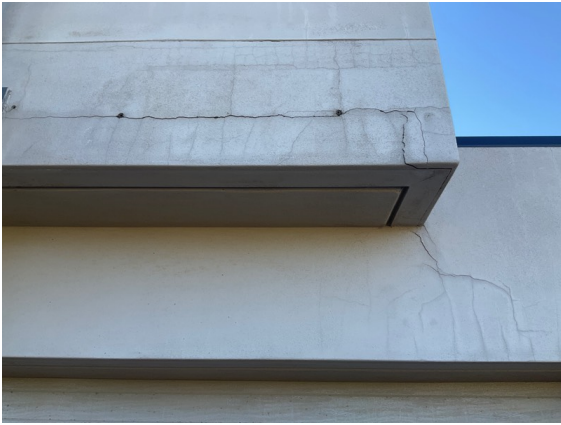
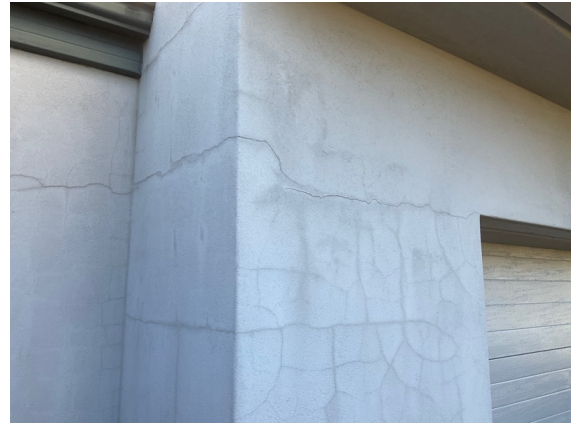
Defect 2. - Exterior

Defect Location:	West Side
Defect Summary:	Walls - Brick
Type of Defect:	Material deterioration
Description:	There is drummy render
Ongoing Consequence:	Damage to surrounding elements
Opinion of Cracking:	Not Applicable
Building Professional:	<b>Note: This defect should be referred to a qualified building professional for the repairs/scope of work required.</b>
	Building Professional Required: Plasterer, Painter

General maintenance

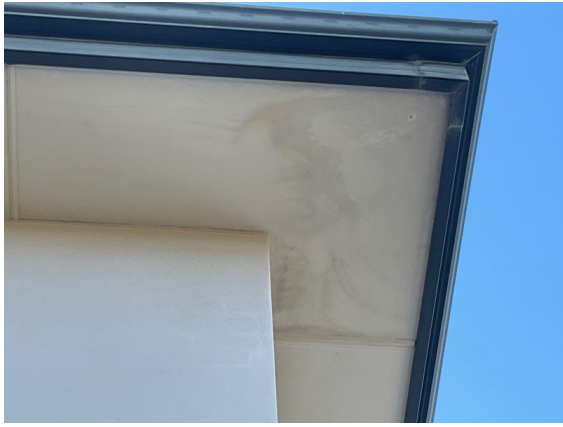
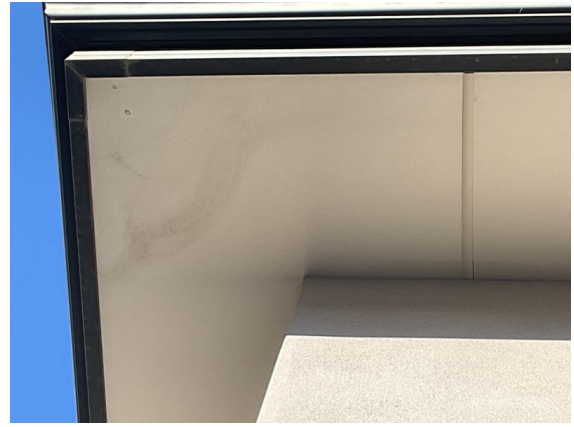
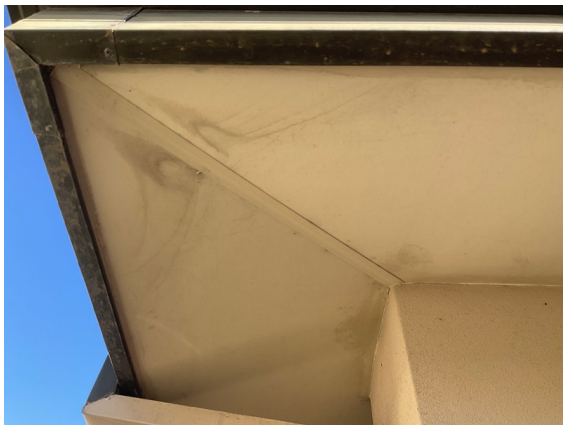
Defect 3. - Roof Exterior

North Side, West Side, South Side

Eaves Fascia and Barges

Water penetration, dampness

Evidence of water ingress

Damage to surrounding elements

**Note: This defect should be referred to a qualified building professional for the repairs/scope of work required.**

Building Professional Required: Roof Plumber

General maintenance

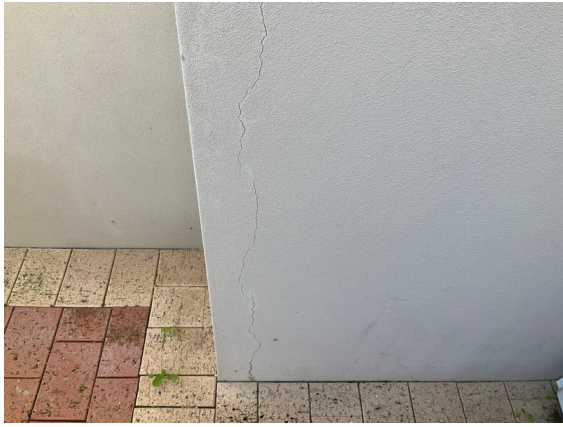
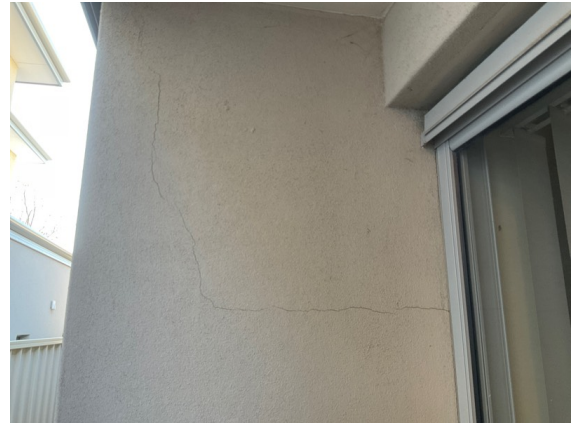
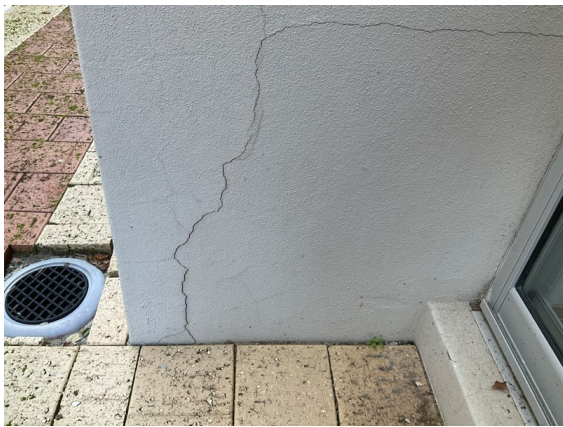
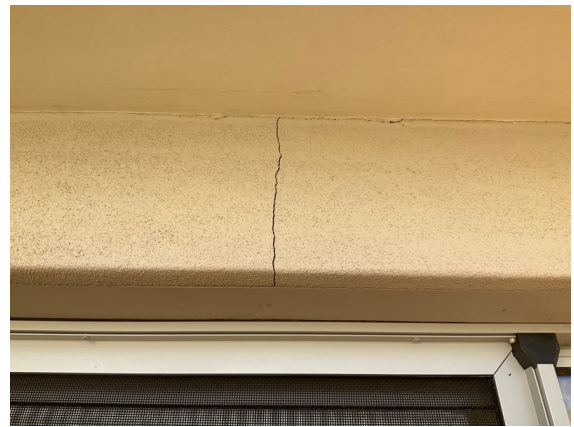
Defect 4. - Exterior

Defect Location:	North Side, South Side
Defect Summary:	Walls - Brick
Type of Defect:	Material deterioration
Description:	There is horizontal cracking, There is vertical cracking
Ongoing Consequence:	Damage to surrounding elements
Opinion of Cracking:	Not Applicable
Building Professional:	<b>Note: This defect should be referred to a qualified building professional for the repairs/scope of work required.</b>
	Building Professional Required: Plasterer, Painter

General maintenance

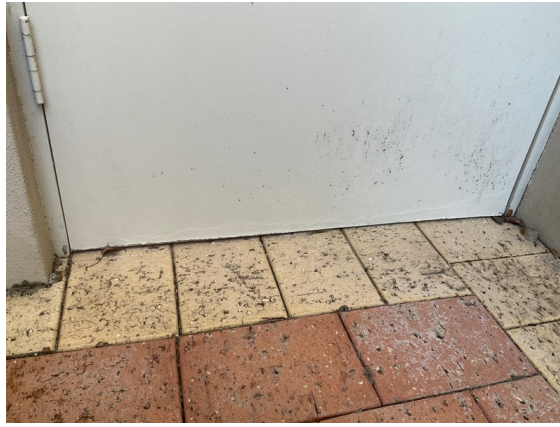
Defect 5. - Interior

Attached Garage

Timber Doors - Water Staining

There is evidence of water staining

Deterioration of the door and/or frame

Building Professional Required: Painter

General maintenance

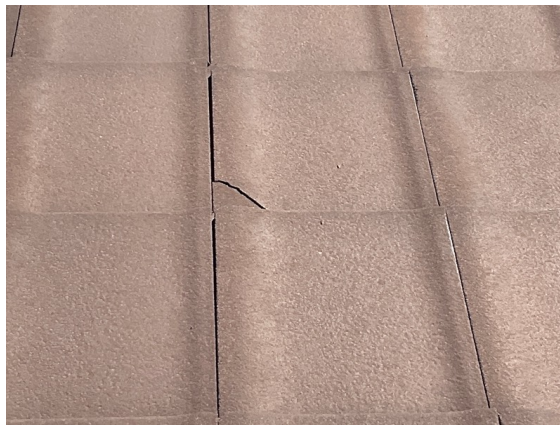
Defect 6. - Roof Exterior

Defect Location:	North Side
Defect Summary:	Roof Coverings
Type of Defect:	Damage
Description:	Tiles are broken
Ongoing Consequence:	Water ingress to Roof Void
Opinion of Cracking:	Not Applicable
Building Professional:	<b>Note: This defect should be referred to a qualified building professional for the repairs/scope of work required.</b>
	Building Professional Required: Roof Tiler

General maintenance

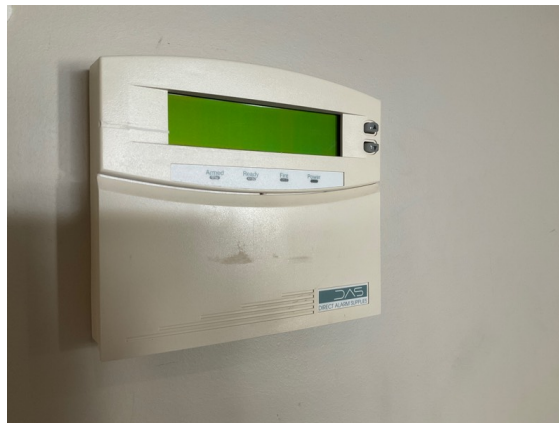
Defect 7. - Interior

Defect Location:	Family Room
Defect Summary:	Security system
Type of Defect:	Operational
Description:	No power to security system
Ongoing Consequence:	Can't use security system
Opinion of Cracking:	Not Applicable
Building Professional:	<b>Note: This defect should be referred to a qualified building professional for the repairs/scope of work required.</b>
	Building Professional Required: Electrician

Owner to rectify

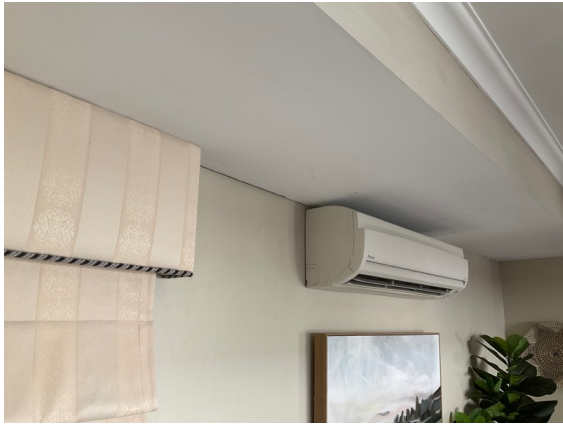
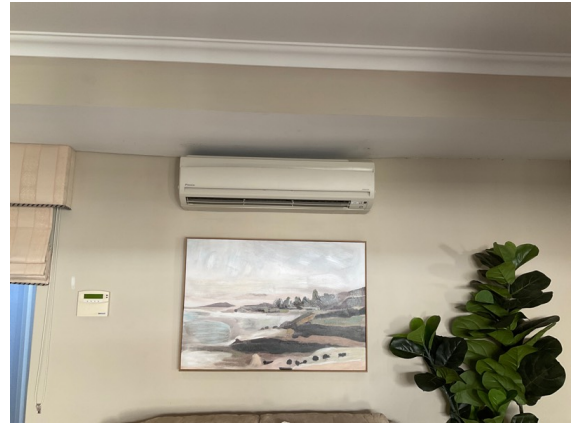
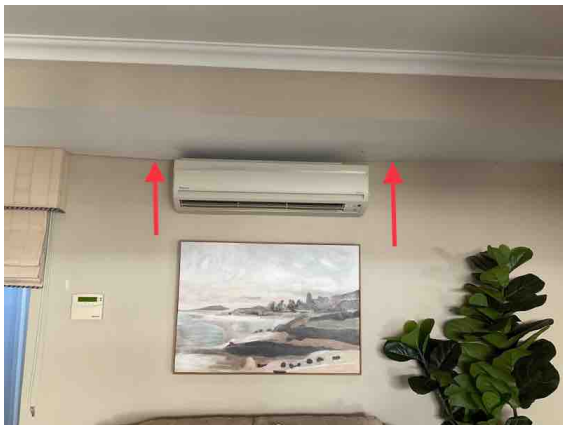
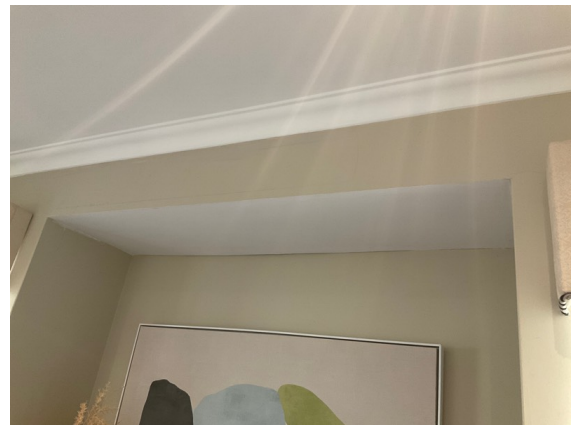
Defect 8. - Interior

Defect Location:	Dining Room, Family Room
Defect Summary:	Ceiling Sagging
Type of Defect:	Material deterioration
Description:	Separation from framing
Ongoing Consequence:	Further sagging or possible collapse
Opinion of Cracking:	Not Applicable
Building Professional:	<b>Note: This defect should be referred to a qualified building professional for the repairs/scope of work required.</b>
	Building Professional Required: Ceiling Fixer

General maintenance

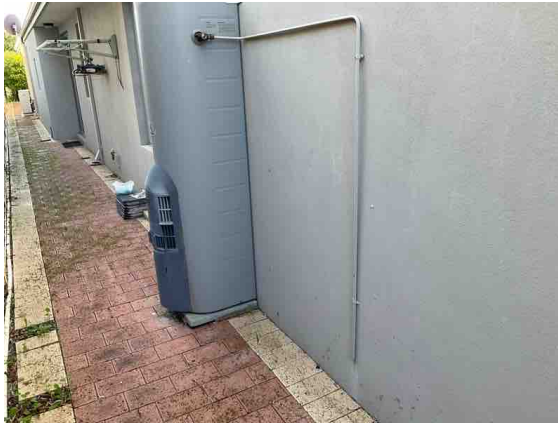
Defect 9. - Interior

Hot water unit

No hot water throughout home

Building Professional Required: Plumber

Owner to rectify

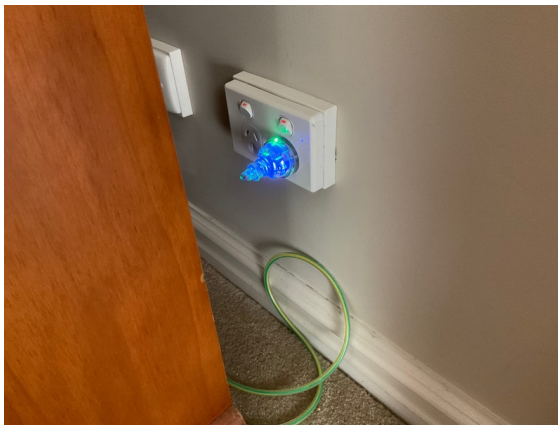
Defect 10. - Interior

Defect Location:	Bedroom 2
Defect Summary:	Power Point
Type of Defect:	Safety hazard
Description:	Power point is loose on wall
Ongoing Consequence:	Possible electrocution
Opinion of Cracking:	Not Applicable
Building Professional:	<b>Note: This defect should be referred to a qualified building professional for the repairs/scope of work required.</b>
	Building Professional Required: Electrician

Owner to rectify

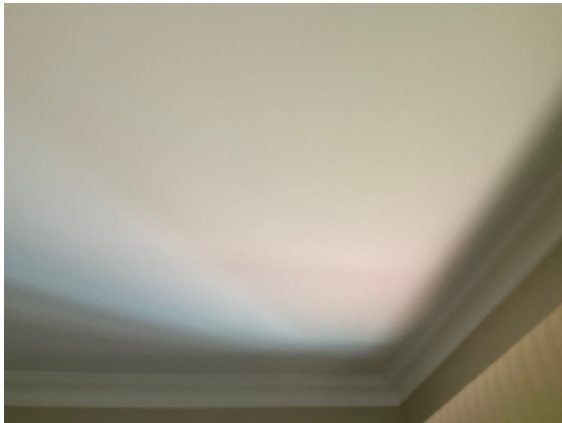
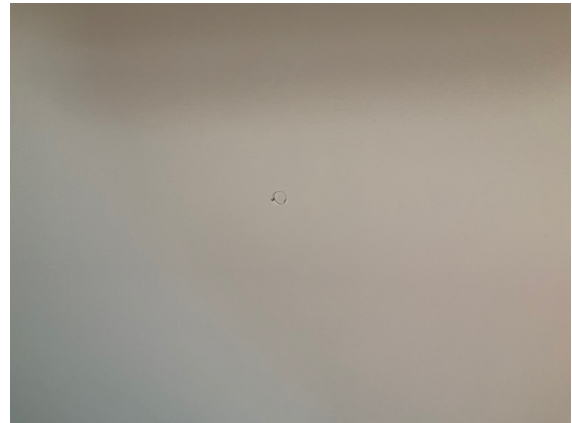
Defect 11. - Interior

Defect Location: Bedroom 2  
Defect Summary: Ceiling Nails Popping  
Type of Defect: Material deterioration  
Description: Sheet fixings are no longer supporting the sheet  
Ongoing Consequence: Further sagging  
Opinion of Cracking: Not Applicable  
Building Professional: **Note: This defect should be referred to a qualified building professional for the repairs/scope of work required.**

Building Professional Required: Ceiling Fixer

General maintenance

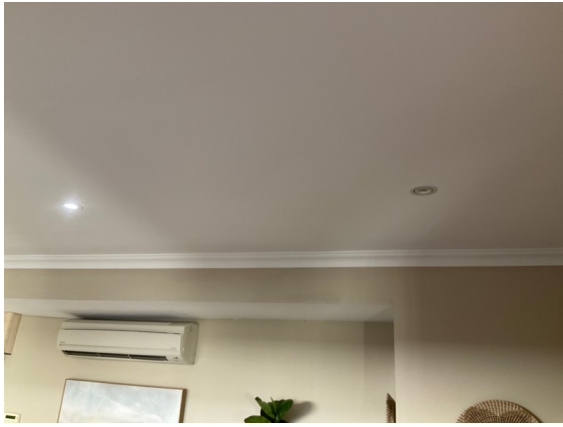
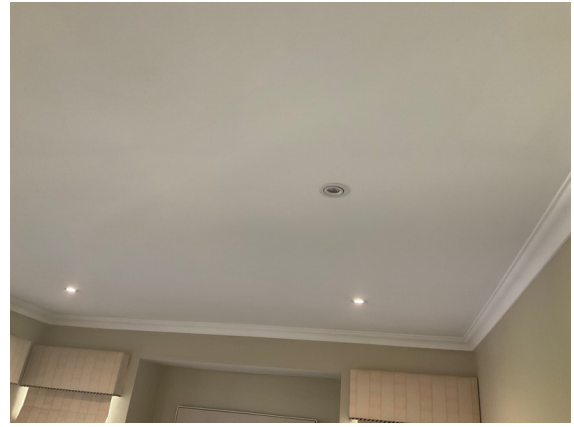
Defect 12. - Interior

Defect Location: Dining Room, Family Room  
Defect Summary: Downlight  
Type of Defect: Operational  
Description: Downlight does not operate  
Ongoing Consequence: Lack of light  
Opinion of Cracking: Not Applicable  
Building Professional: **Note: This defect should be referred to a qualified building professional for the repairs/scope of work required.**

Building Professional Required: Electrician

Owner to rectify

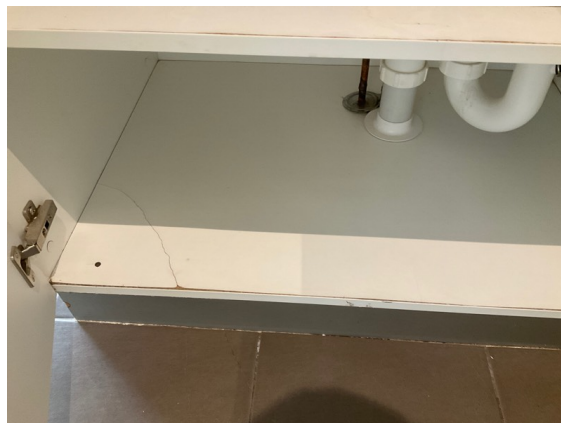
Defect 13. - Interior

Defect Location:	Kitchen
Defect Summary:	Cupboards
Type of Defect:	Water penetration, dampness
Description:	There is evidence of water staining
Ongoing Consequence:	Water ingress will affect the serviceability of the cupboards
Opinion of Cracking:	Not Applicable
Building Professional:	<b>Note: This defect should be referred to a qualified building professional for the repairs/scope of work required.</b>
	Building Professional Required: Carpenter

General maintenance - sink is now not leaking at the time of inspection

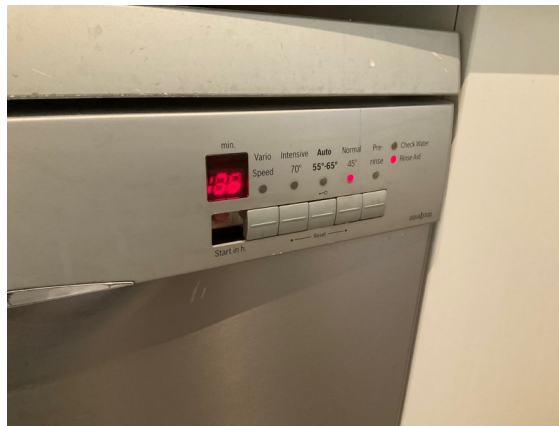
Defect 14. - Interior

Defect Location:	Kitchen
Defect Summary:	Dishwasher
Type of Defect:	Damage
Description:	Button missing from dishwasher
Ongoing Consequence:	None as dishwasher still operates
Opinion of Cracking:	Not Applicable
Building Professional:	<b>Note: This defect should be referred to a qualified building professional for the repairs/scope of work required.</b>
	Building Professional Required: Plumber

General maintenance

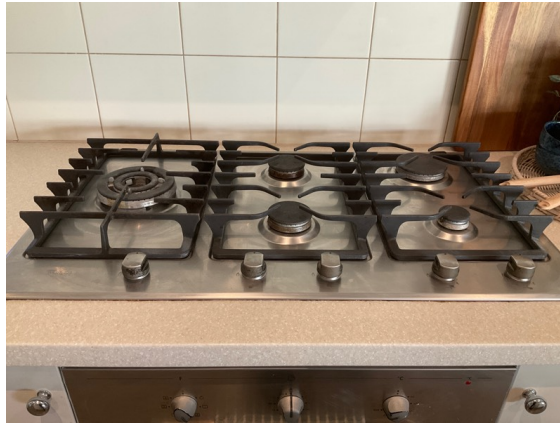
Defect 15. - Interior

Defect Location:	Kitchen
Defect Summary:	Gas cook top
Type of Defect:	Operational
Description:	Could not operate gas cooktop
Ongoing Consequence:	Can't use burners
Opinion of Cracking:	Not Applicable
Building Professional:	<b>Note: This defect should be referred to a qualified building professional for the repairs/scope of work required.</b>
	Building Professional Required: Plumber

Owner to rectify

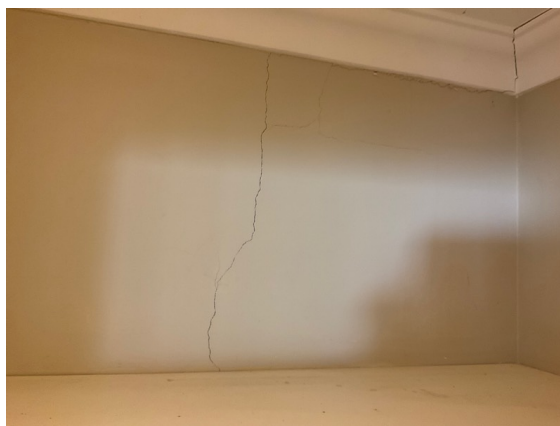
Defect 16. - Interior

Defect Location:	Walk in Pantry
Defect Summary:	Walls - Brick
Type of Defect:	Material deterioration
Description:	There is vertical cracking
Ongoing Consequence:	Damage to surrounding elements
Opinion of Cracking:	Not Applicable
Building Professional:	<b>Note: This defect should be referred to a qualified building professional for the repairs/scope of work required.</b>
	Building Professional Required: Painter

General maintenance

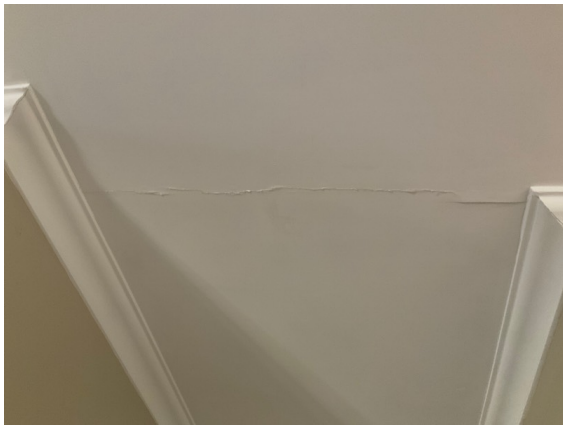
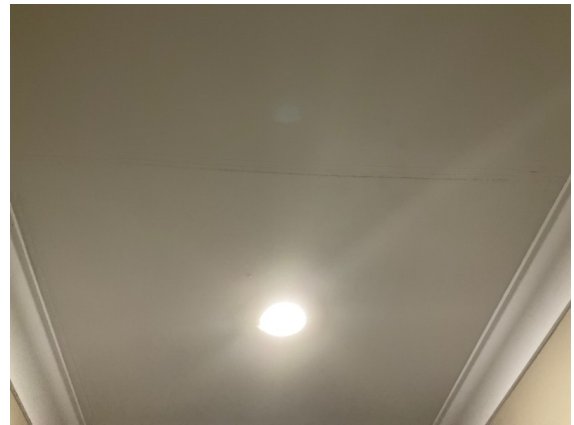
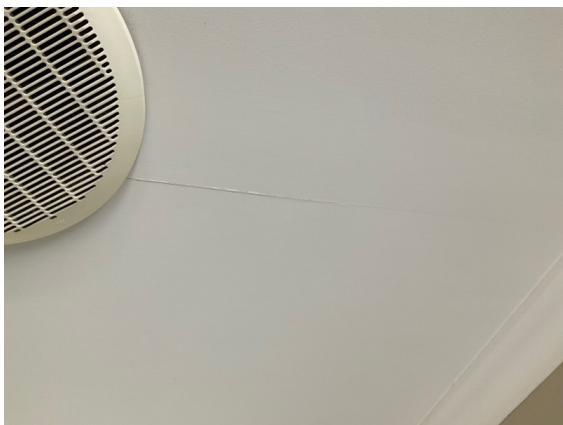
Defect 17. - Interior

Defect Location:	Ensuite 1, Hallway
Defect Summary:	Ceiling Cracking and/or evidence of damage repaired
Type of Defect:	Material deterioration
Description:	Cracking
Ongoing Consequence:	Further cracking
Opinion of Cracking:	Not Applicable
Building Professional:	<b>Note: This defect should be referred to a qualified building professional for the repairs/scope of work required.</b>
	Building Professional Required: Ceiling Fixer, Painter

General maintenance

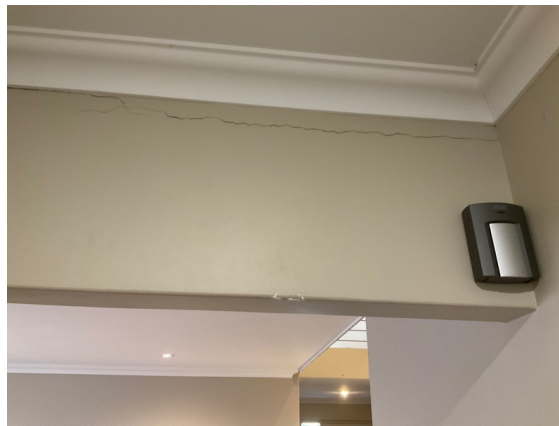
Defect 18. - Interior

Defect Location:	Hallway
Defect Summary:	Walls - Brick
Type of Defect:	Material deterioration
Description:	There is horizontal cracking
Ongoing Consequence:	Damage to surrounding elements
Opinion of Cracking:	Not Applicable
Building Professional:	<b>Note: This defect should be referred to a qualified building professional for the repairs/scope of work required.</b>
	Building Professional Required: Painter

General maintenance

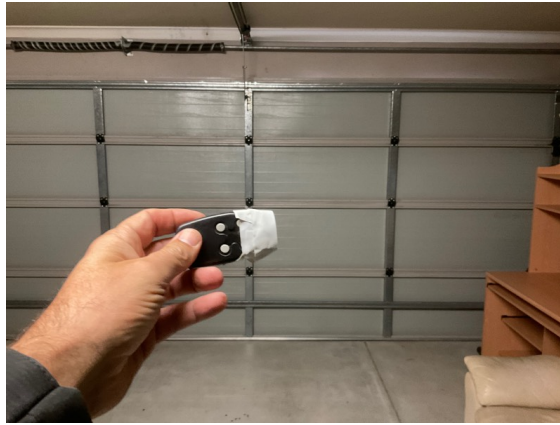
Defect 19. - Interior

Defect Location:	Attached Garage
Defect Summary:	Garage door remote
Type of Defect:	Operational
Description:	Remote control batteries are flat
Ongoing Consequence:	Can't open garage door with remote
Opinion of Cracking:	Not Applicable
Building Professional:	<b>Note: This defect should be referred to a qualified building professional for the repairs/scope of work required.</b>
	Building Professional Required: Electrician

Owner to rectify

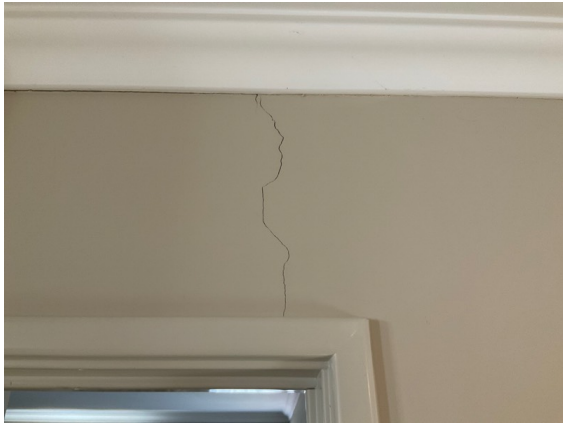
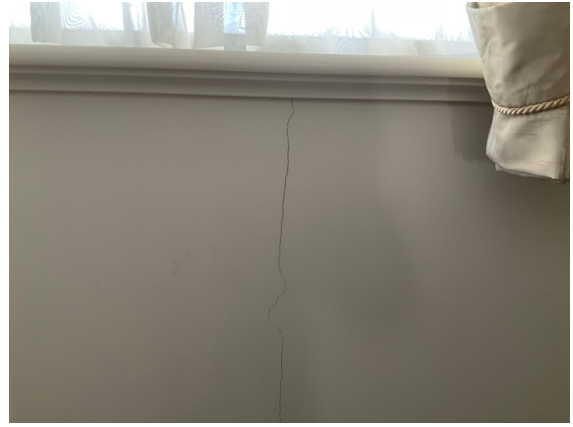
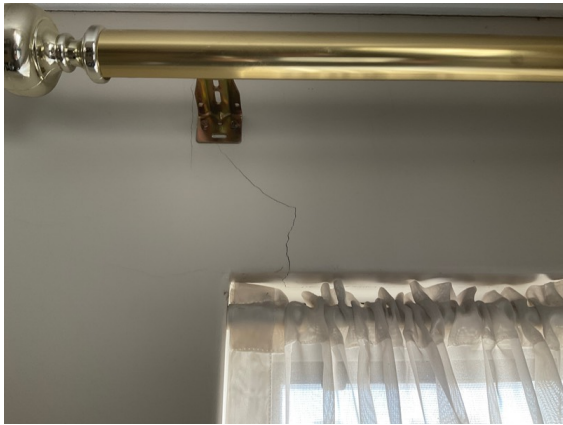
#### Defect 20. - Interior

Defect Location:	Upstairs Living
Defect Summary:	Walls - Brick
Type of Defect:	Material deterioration
Description:	There is vertical cracking
Ongoing Consequence:	Damage to surrounding elements
Opinion of Cracking:	Not Applicable
Building Professional:	<b>Note: This defect should be referred to a qualified building professional for the repairs/scope of work required.</b>
	Building Professional Required: Painter

General maintenance

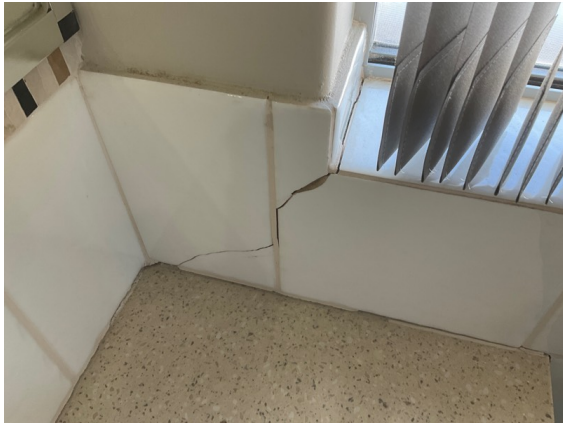
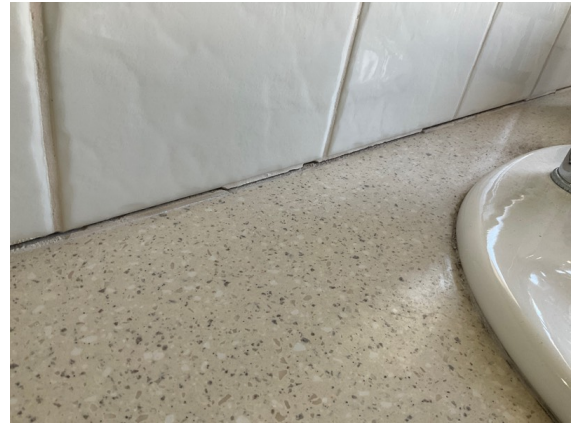
Defect 21. - Interior

Ensuite 1

Tiles

There are cracked wall tiles

Deterioration of surrounding elements

Building Professional Required: Tiler

General maintenance

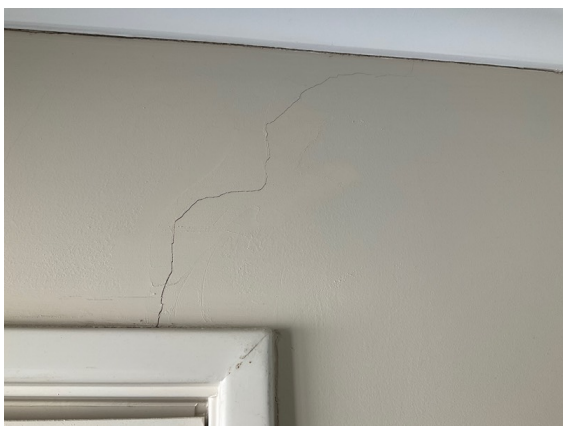
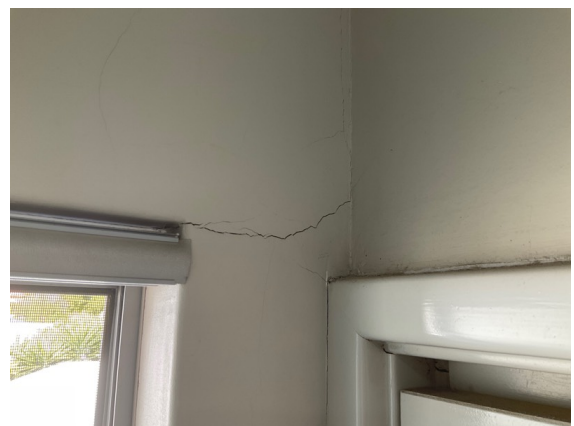
Defect 22. - Interior

Ensuite 1

Walls - Brick

There is vertical cracking

Damage to surrounding elements

Building Professional Required: Painter

General maintenance

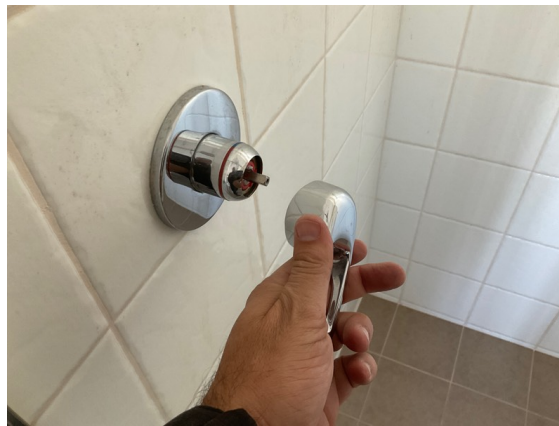
Defect 23. - Interior

Defect Location:	Ensuite 1
Defect Summary:	Taps
Type of Defect:	Damage, Operational
Description:	Shower tap is damaged
Ongoing Consequence:	Can't operate shower
Opinion of Cracking:	Not Applicable
Building Professional:	<b>Note: This defect should be referred to a qualified building professional for the repairs/scope of work required.</b>
	Building Professional Required: Plumber

Owner to rectify

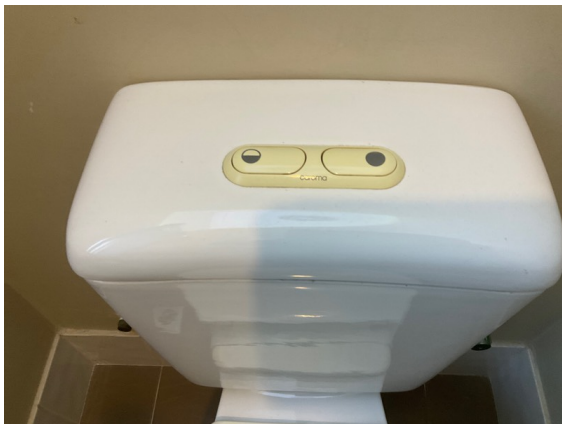
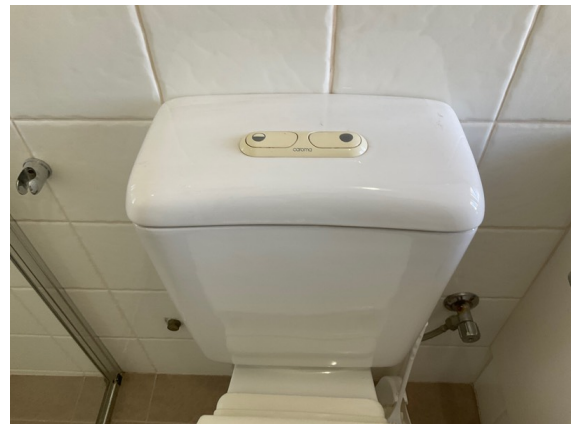
Observation 1

Area Location:	Toilet & Ensuite
Description:	Toilet is difficult to flush

General maintenance

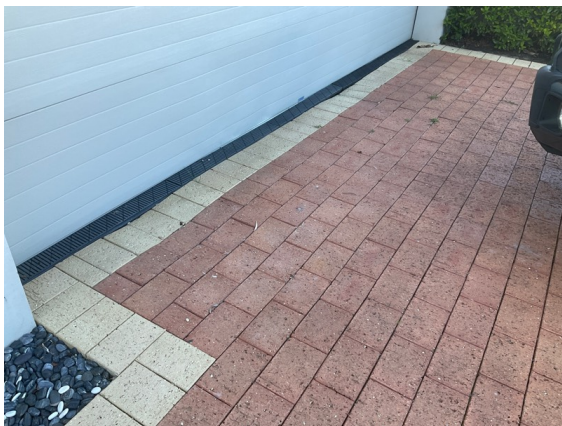
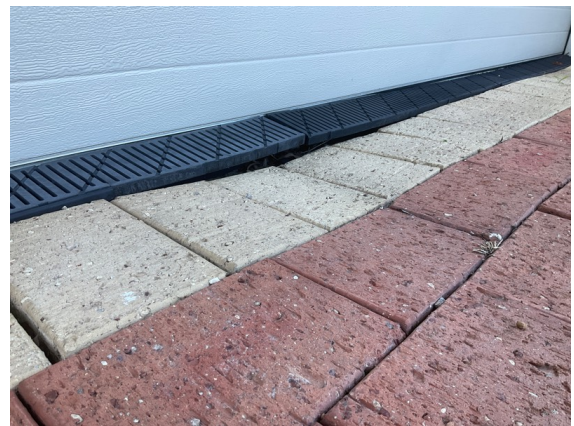
Site Defect 1. - Paths and Driveways

Type of Defect: The driveway has subsided  
Direction: West  
Description: Material deterioration  
Ongoing Consequence: The driveway may become unserviceable  
Opinion of Cracking: Not Applicable  
Building Professional: **Note: This defect should be referred to a qualified building professional for the repairs/scope of work required.**  
Building Professional Required: Paver

General maintenance

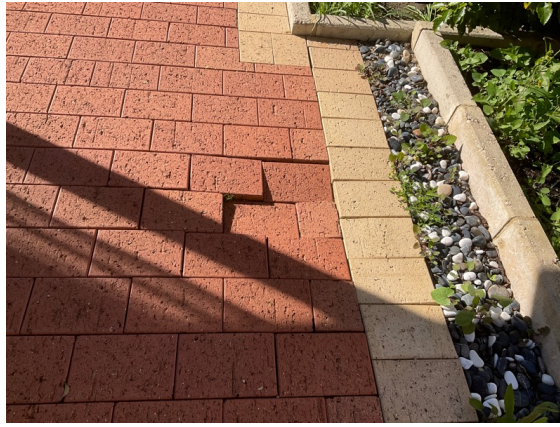
Site Defect 2. - Paths and Driveways

Type of Defect: The path has subsided  
Direction: South  
Description: Material deterioration  
Ongoing Consequence: The path may become unserviceable  
Opinion of Cracking: Not Applicable  
Building Professional: **Note: This defect should be referred to a qualified building professional for the repairs/scope of work required.**  
Building Professional Required: Paver

General maintenance
